Belladonna Home Inspections

Property Inspection Report

123 Somewhere Street, Gainesville, GA 30506
Inspection prepared for: Sample Sampler
Real Estate Agent: Test Tester - Test

Date of Inspection: 11/6/2015 Time: 10:00 am
Age of Home: 9 Size: 1578
Weather: Rainy

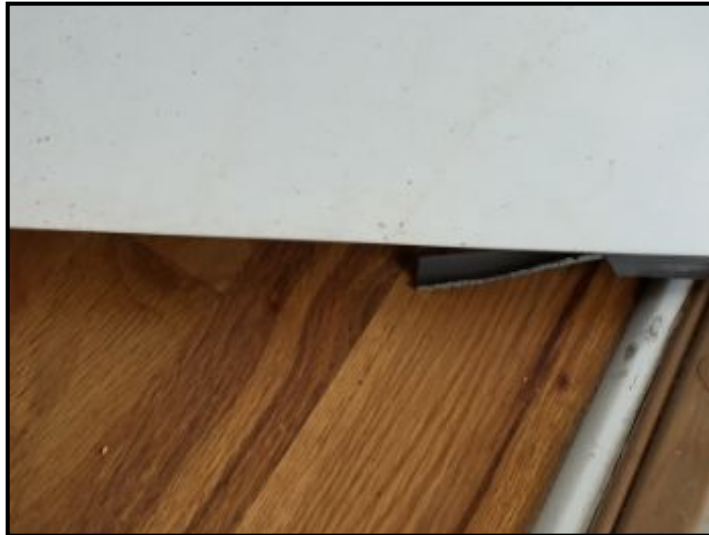
Weather strip at bottom of entrance door has been tore - should be replaced to prevent cold air from entering house.

- Weather strip at bottom of entrance door has been tore - should be replaced to prevent cold air from entering house.

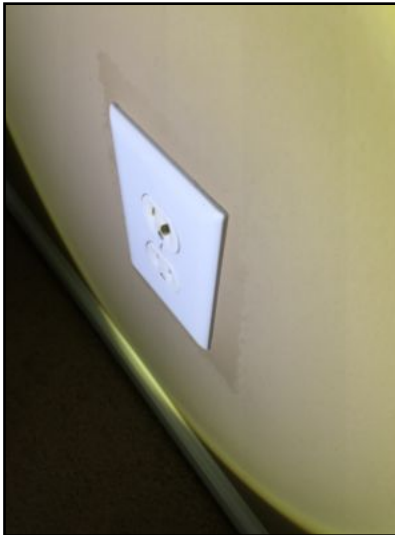
Outlet has broken prong still lodged in outlet - suggest replacing.

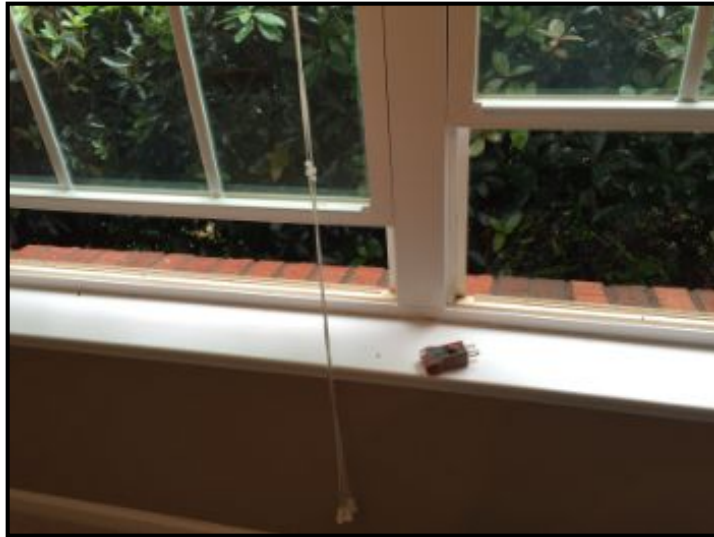
Missing window screens.

- Missing window screens.

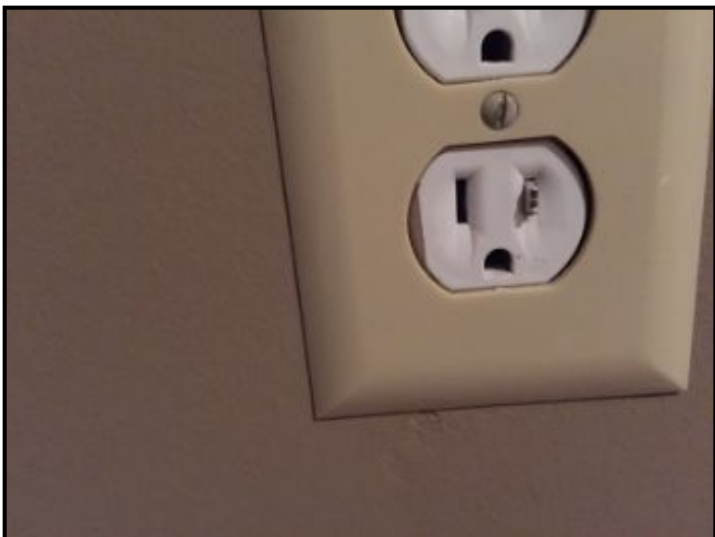
Prong broken off inside outlet - should be replaced.

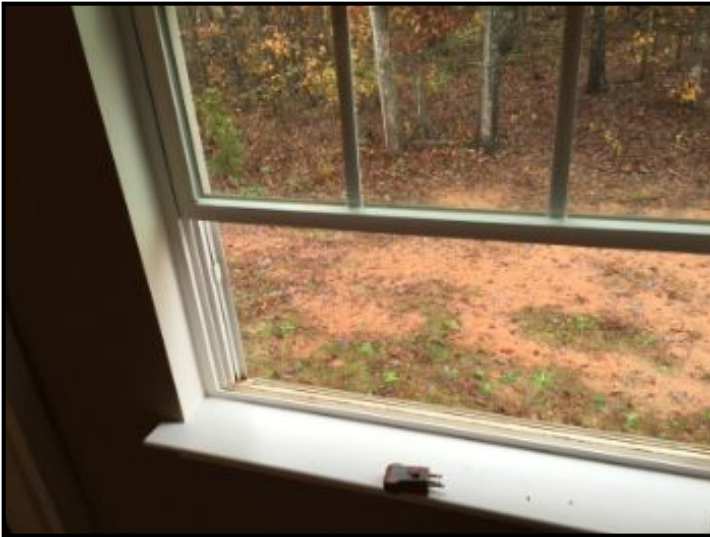
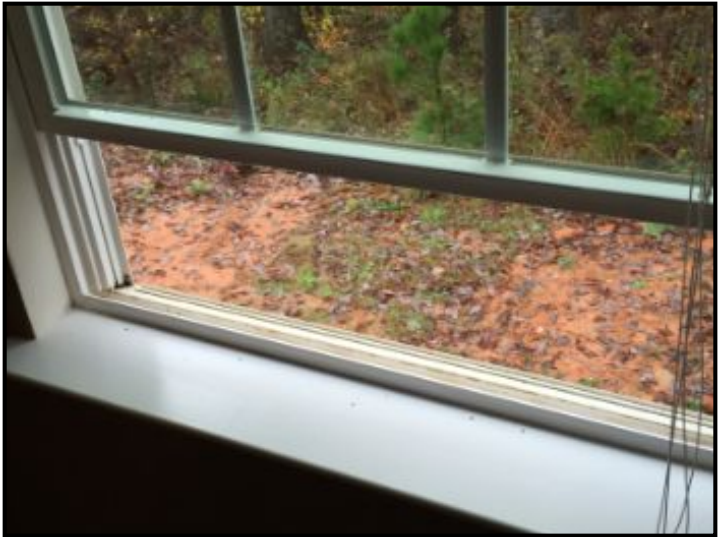
Windows worked properly, but lacked window screens.

Windows worked properly, but no window screens installed.

- Windows worked properly, but no window screens installed.

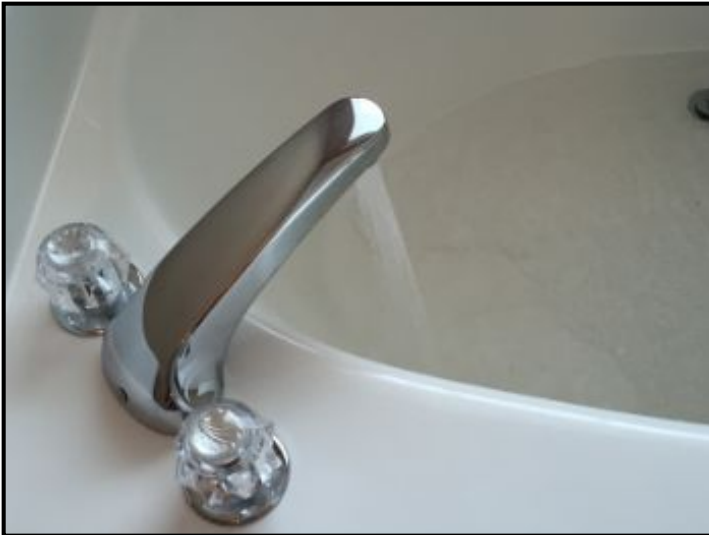
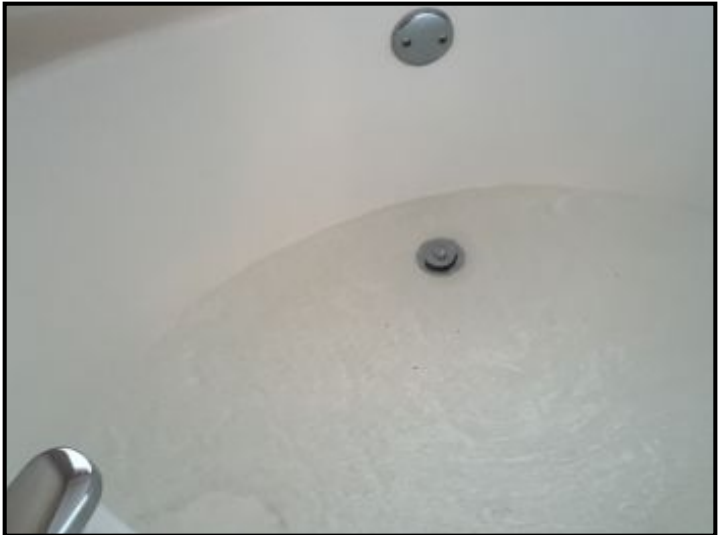
Master bathtub worked properly - drain was slow.

Slow drain - recommend cleaning.

- Slow drain - recommend cleaning.

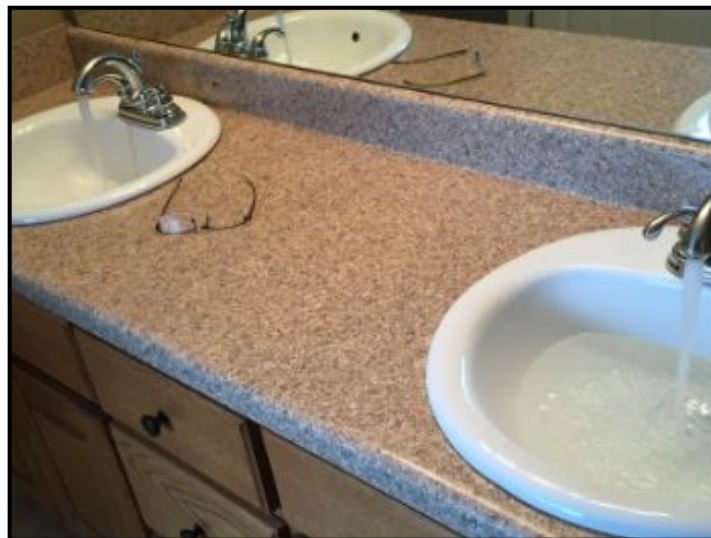
Slow drain at right sink in master bedroom. Recommend clearing.

- Slow drain at right sink in master bedroom. Recommend clearing.

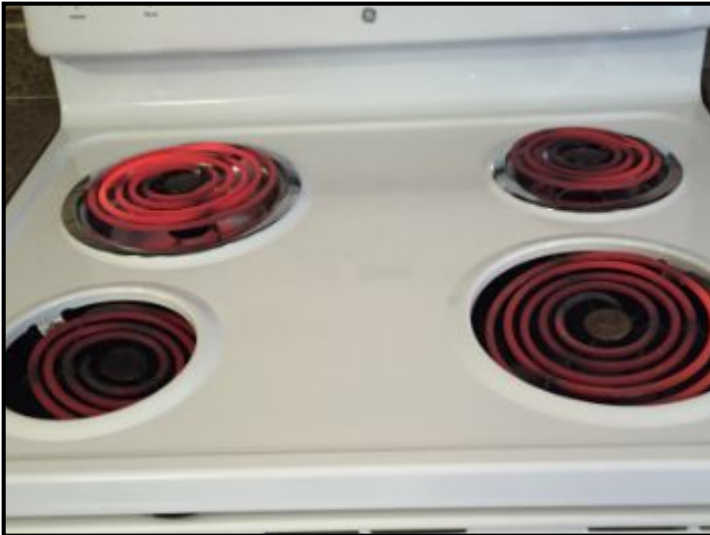
Functioned properly, but front two eyes missing drip pans.

- Functioned properly, but front two eyes missing drip pans.

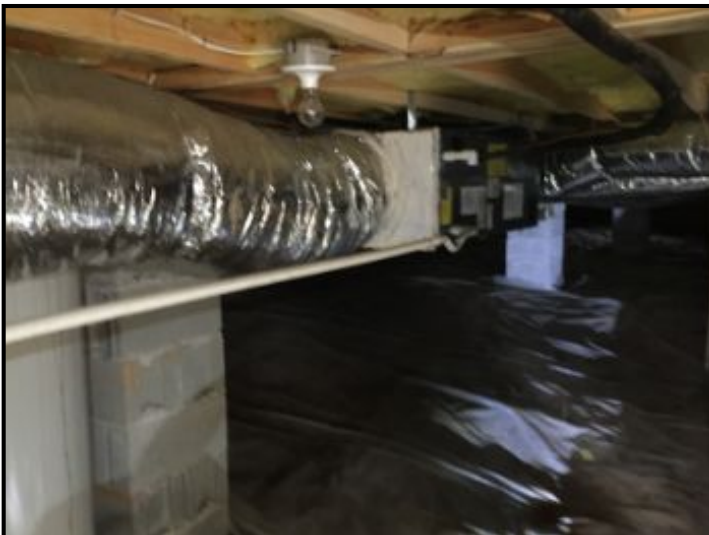
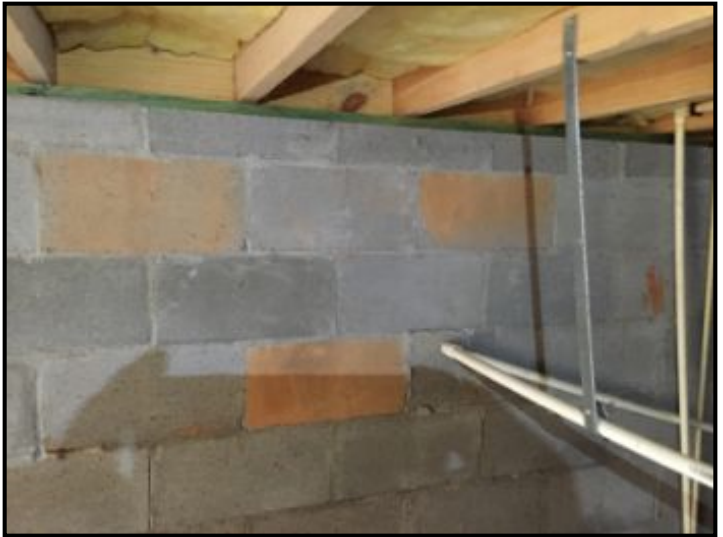
PVC drain pipe leaving heater has swag where water cannot effective drain - recommend fixing to where there is a continual slope downward to this pipe for proper drainage.

- The heater base appears to be functional.
- PVC drain pipe leaving heater has swag where water cannot effective drain - recommend fixing to where there is a continual slope downward to this pipe for proper drainage.

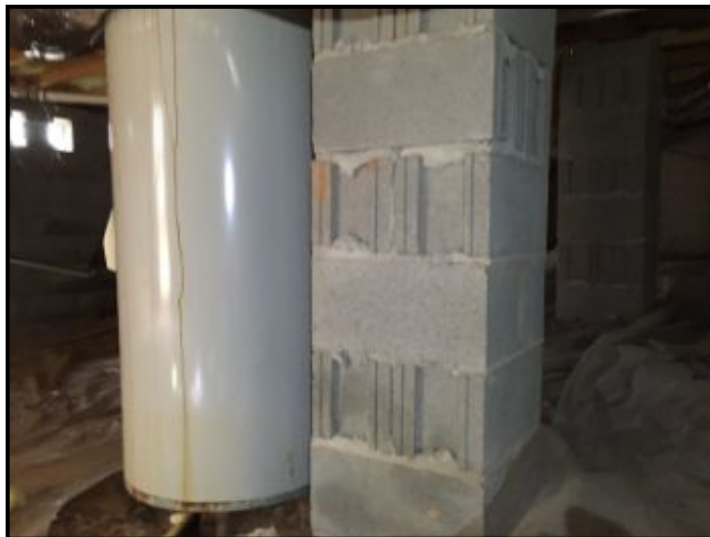
The water heater enclosure has stain running down tank - make sure it doesn't have a leak coming from the top.

- The water heater enclosure has stain running down tank - make sure it doesn't have a leak coming from the top.

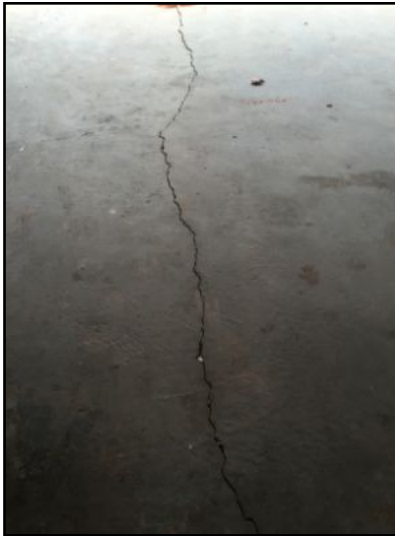
Crack noted which is normal - this one has some rise to it, but I don't think it will be an issue.

- Crack noted which is normal - this one has some rise to it, but I don't think it will be an issue.

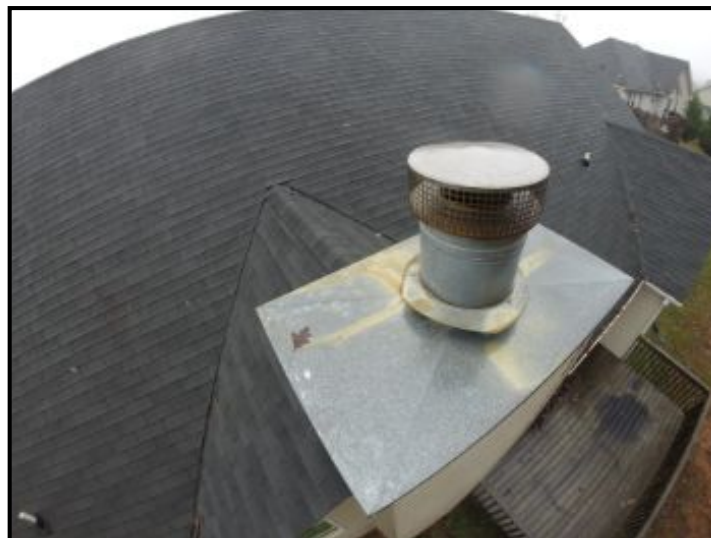
Some rusting noted, but I do not feel that anything has been compromised.

- Some rusting noted, but I do not feel that anything has been compromised.

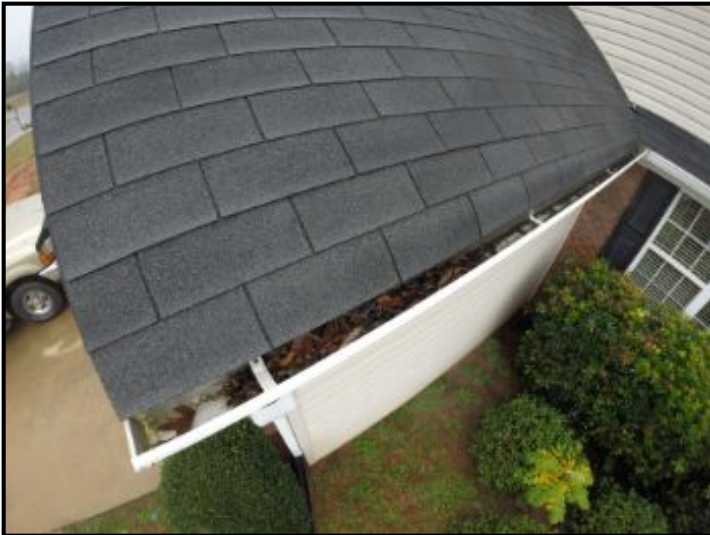
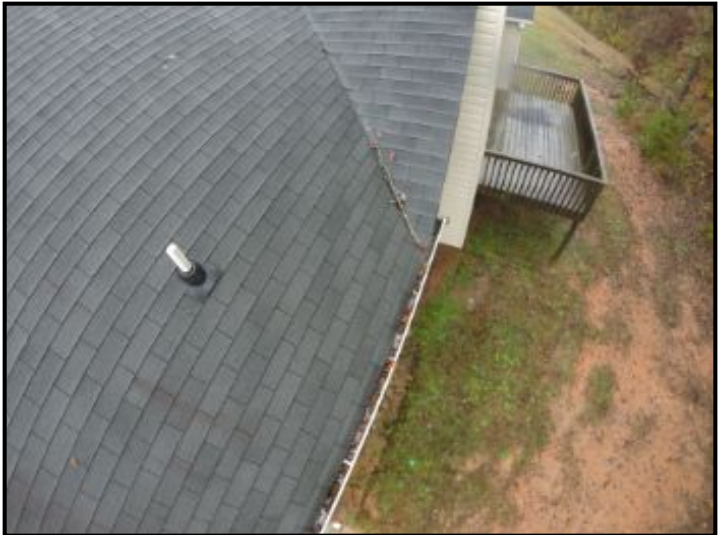
Clean gutters: Significant amounts of debris evident.

- Clean gutters: Significant amounts of debris evident.
- Downspout should be installed closer to the ground to keep water from impacting ground and causing holes if splash guard is moved.
- Missing splash plate.

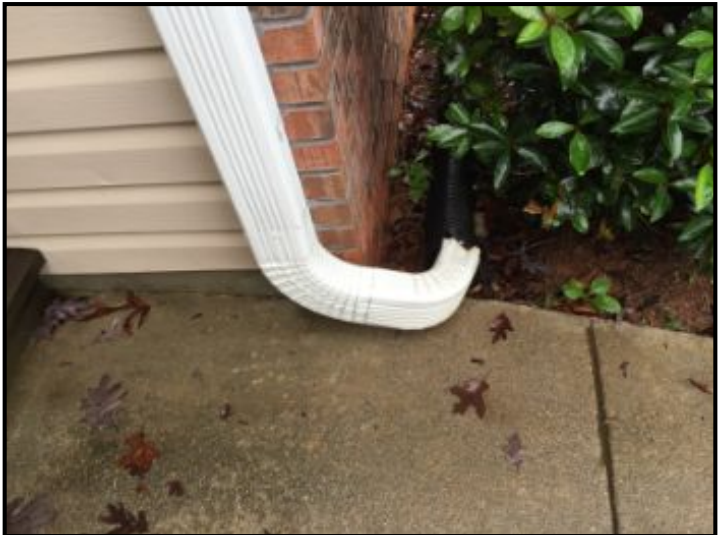
Downspout routing water away from house - may need to seal connection better if loose.

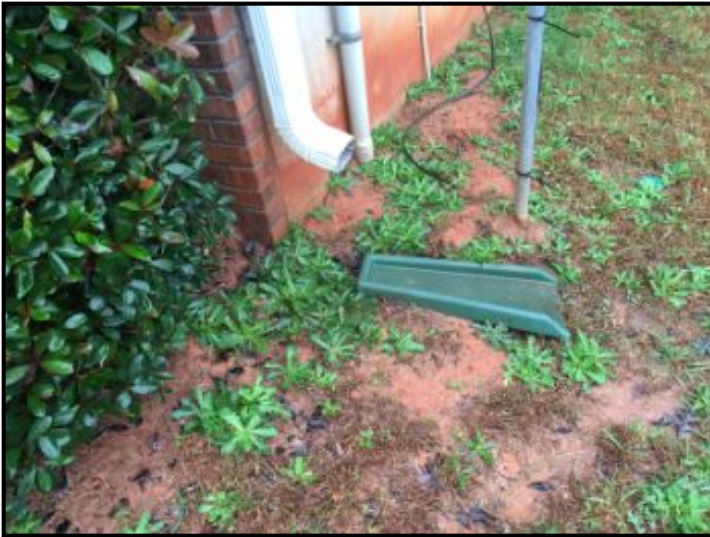
Downspout should be installed closer to the ground to keep water from impacting ground and causing holes if splash guard is moved.

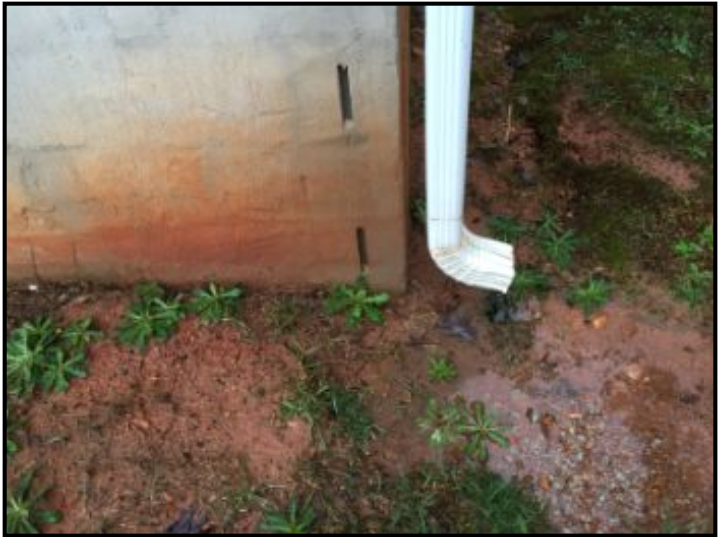
Missing splash plate.

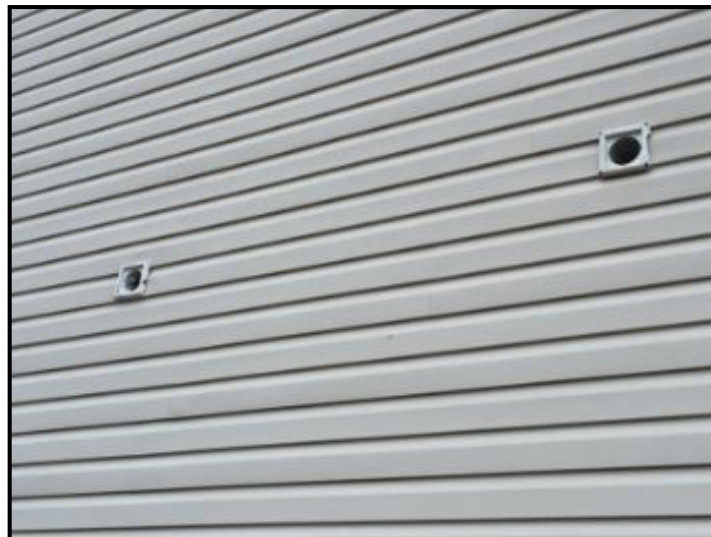
Two vent covers missing on outside of siding.

- No major system safety or function concerns noted at time of inspection.
- Two vent covers missing on outside of siding.

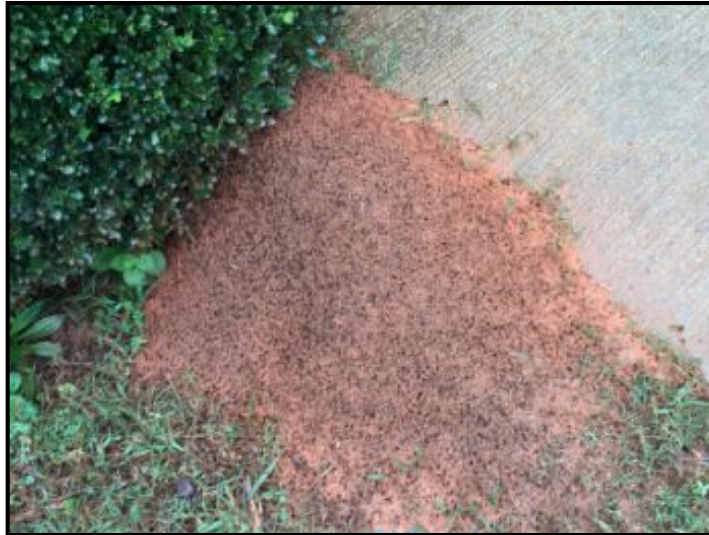
Fire ant mound located on side of driveway near garage.

- Driveway in good shape. Recommend sealing to extend life.
- Fire ant mound located on side of driveway near garage.

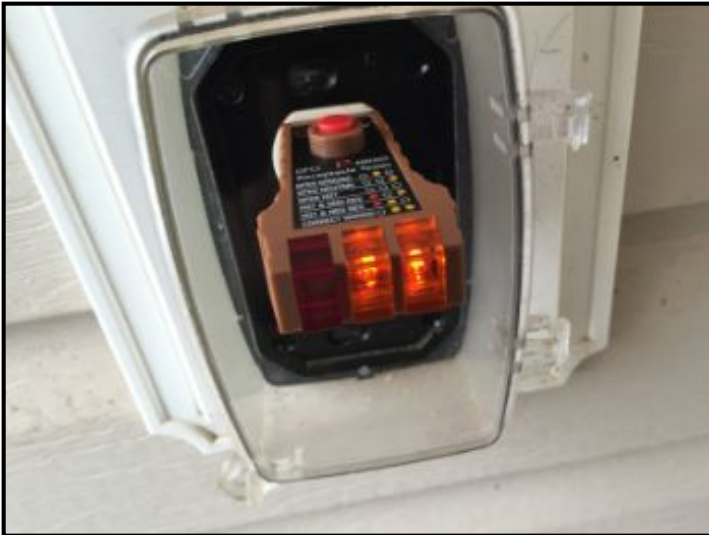
Front outlet did not appear to be GFCI compliant - should replace with GFCI outlet if not.

- Front outlet did not appear to be GFCI compliant - should replace with GFCI outlet if not.

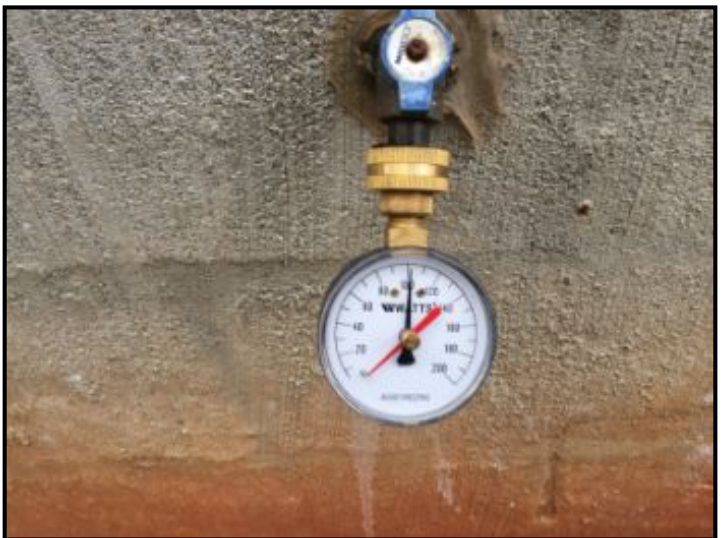
High pressure.

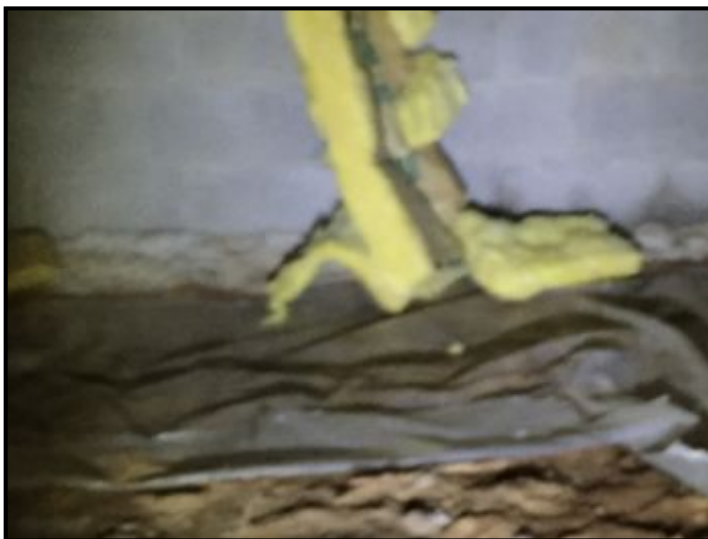
Recommend putting fallen batts back in place to improve efficiency.

- Recommend putting fallen batts back in place to improve efficiency.

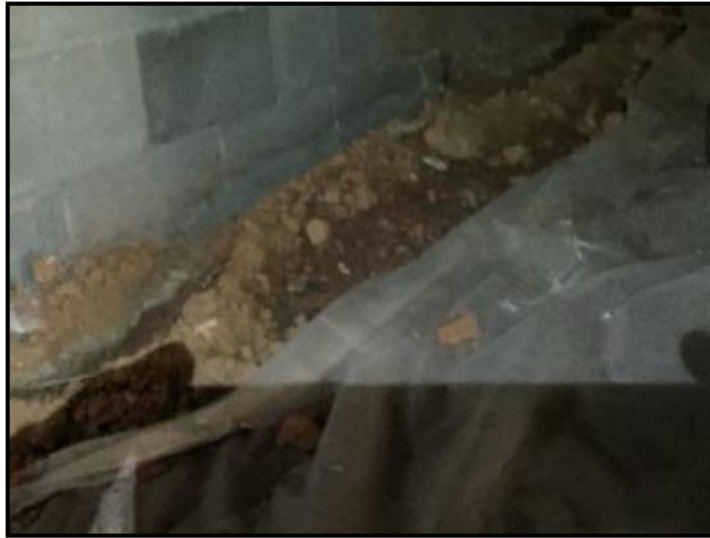
Looks like plastic vapor barrier was pulled back and was trenched to put in pesticide.
